# Problems with modern diesel fuel injectors on low emissions engines

## Summary

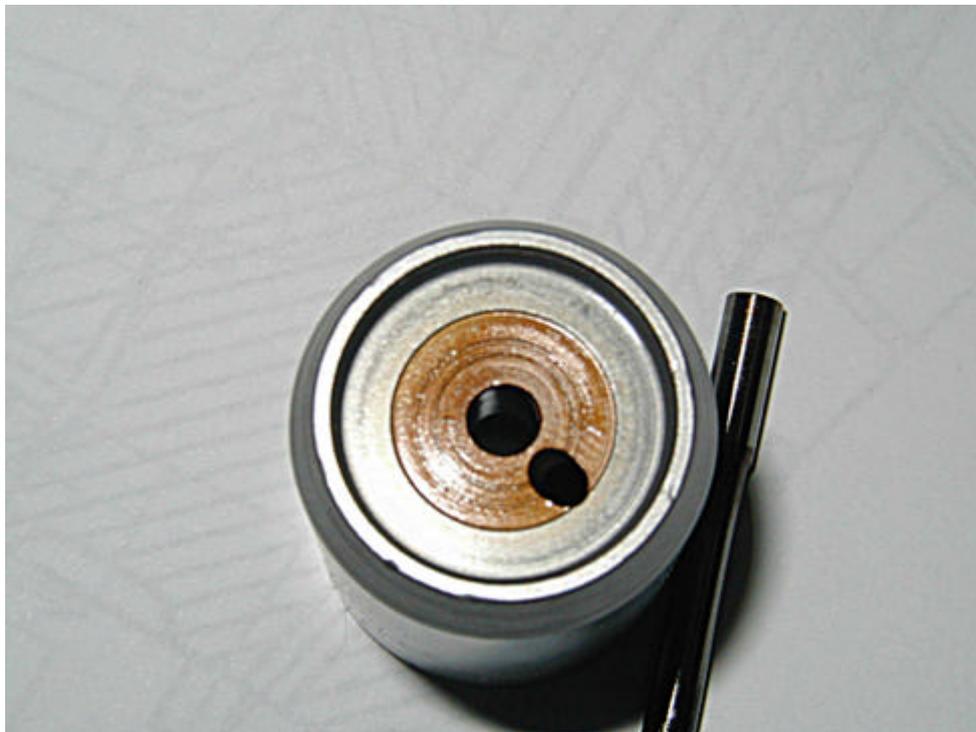
The modern diesel engine uses a fuel filter with a much finer mesh inside than was traditionally used and bacterial infection of the fuel may manifest itself in the form of short filter life. The problem is caused by the residue left behind in the fuel when the bacteria die. This can have the appearance of a brown coloured stain and can be removed from metallic surfaces it has come into contact with by gently rubbing it with a finger tip. This residue will stick to the filter and clog it fairly quickly but some of the residue will pass through the filter and end up on the surfaces of the fuel system. The photograph below shows an example of this coating on the back end of the fuel injector nozzle. The brown tarnish is only present where the fuel has come into contact with the metal.

The first course of action should be to identify the source of the bacterial infection. Air BP\* sell an easy to use microbial test kit that allows the end user to identify the presence of bacterial infection in fuel. Once a source has been identified the user should contact their fuel supplier.

If there is found to be a bacterial infection in the fuel then it will be necessary to either stop using that tank or dose the fuel in the tank with a specific disinfectant. The fuel in the tank will then have to be filtered using a special filtration system to remove the bacterial residues. It may be more appropriate to install a new tank and review the process used to maintain the tank with respect to water drains and tank breathers.

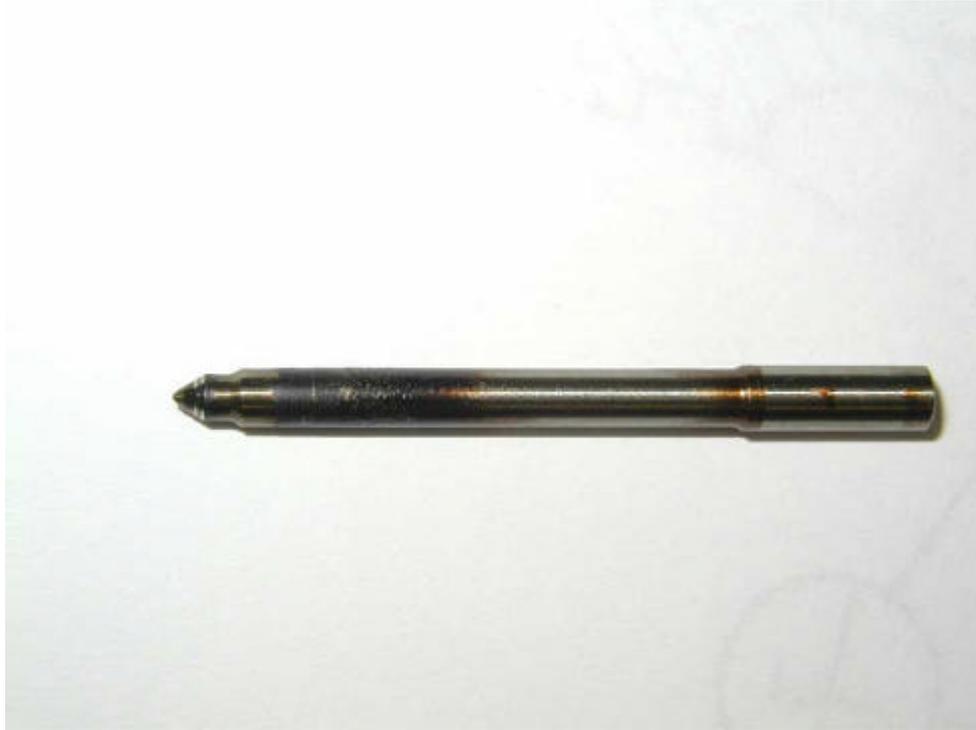
More serious is what happens when the bacterial residue is heated. The photograph below shows the needle from the same injector nozzle assembly:

In this case the residue has been carburised (turned to soot). This is not because the needle has been leaking; right up until the failure of the injector the engine was running evenly and the emissions analyser measuring the exhaust gas from the engine showed no signs of a fault of this nature. The engine had been shut down from full power (850 HP) by an alarm trip and the injector was found to be faulty on re-start, some thirty minutes after the original shutdown.

The carburised look comes about because the bacterial residue contains a lot of sugars which are being caramelised by the heat. This does not require a particularly high temperature to take place either. On this injector it was necessary to use a brass drift to punch the spill control valve spool from its body. When the spool was removed it was found to be covered in a dry residue showing partial signs of caramelising.

The spill control valve is surrounded by the windings of the electromagnet used to operate it. The windings are normally cooled by the fuel flowing through the spill control valve. In the event of a fast shutdown of the engine after heavy work or due to an emergency stop the heat from the engine “soaks” up through the cylinder head and up through the injector causing the temperature of the spill control valve to rise. The temperatures seen on an engine shut down in this way can be very high because the water pump is not moving the water round the engine and “after boiling” can take place. Because of this the temperature around the spill control valve may rise high enough to cause the bacterial residue to become caramelised. The sticky layer of caramel in the very tight clearances of the spill control valve will exert enough force to prevent the valve from operating and the injector fails.

- 1) Shut the engine down in a controlled fashion, idle down as you would for a turbocharger. This will help prevent the engine from heat soaking the injector.
- 2) If it is necessary to shut down the engine in an emergency try get it restarted as soon as possible and allow it to cool down as above.
- 3) Use fuel from a known "clean" supply and avoid using fuel cans wherever possible.
- 4) Check your fuel tank regularly for bacterial infection, just before ordering the next batch of fuel to limit the amount of cleaning required.
- 5) Look out for signs of bacterial residue during filter changes and use short filter life as a warning of possible problems.
